**SUPERIOR COURT OF THE DISTRICT OF COLUMBIA  
CRIMINAL DIVISION—FELONY BRANCH**

**Government’s Motion to Dismiss the Indictment**

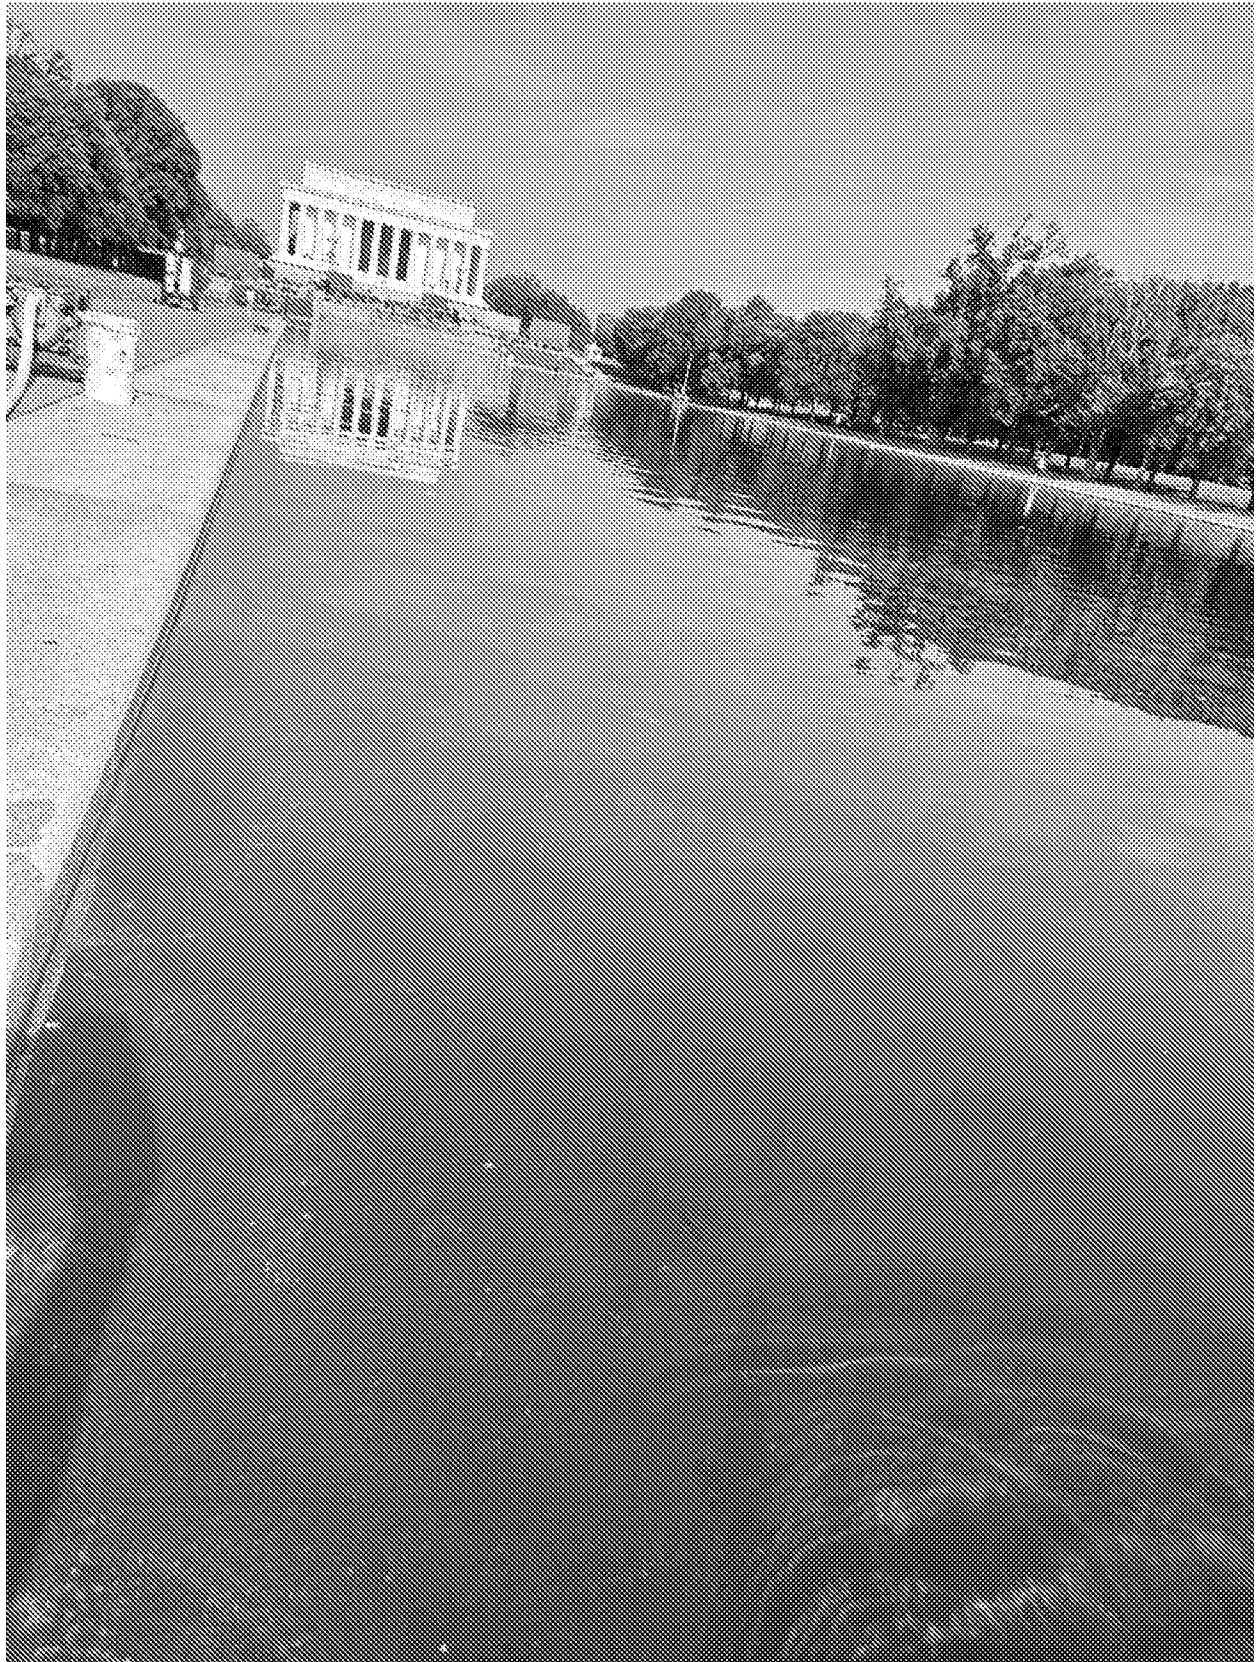
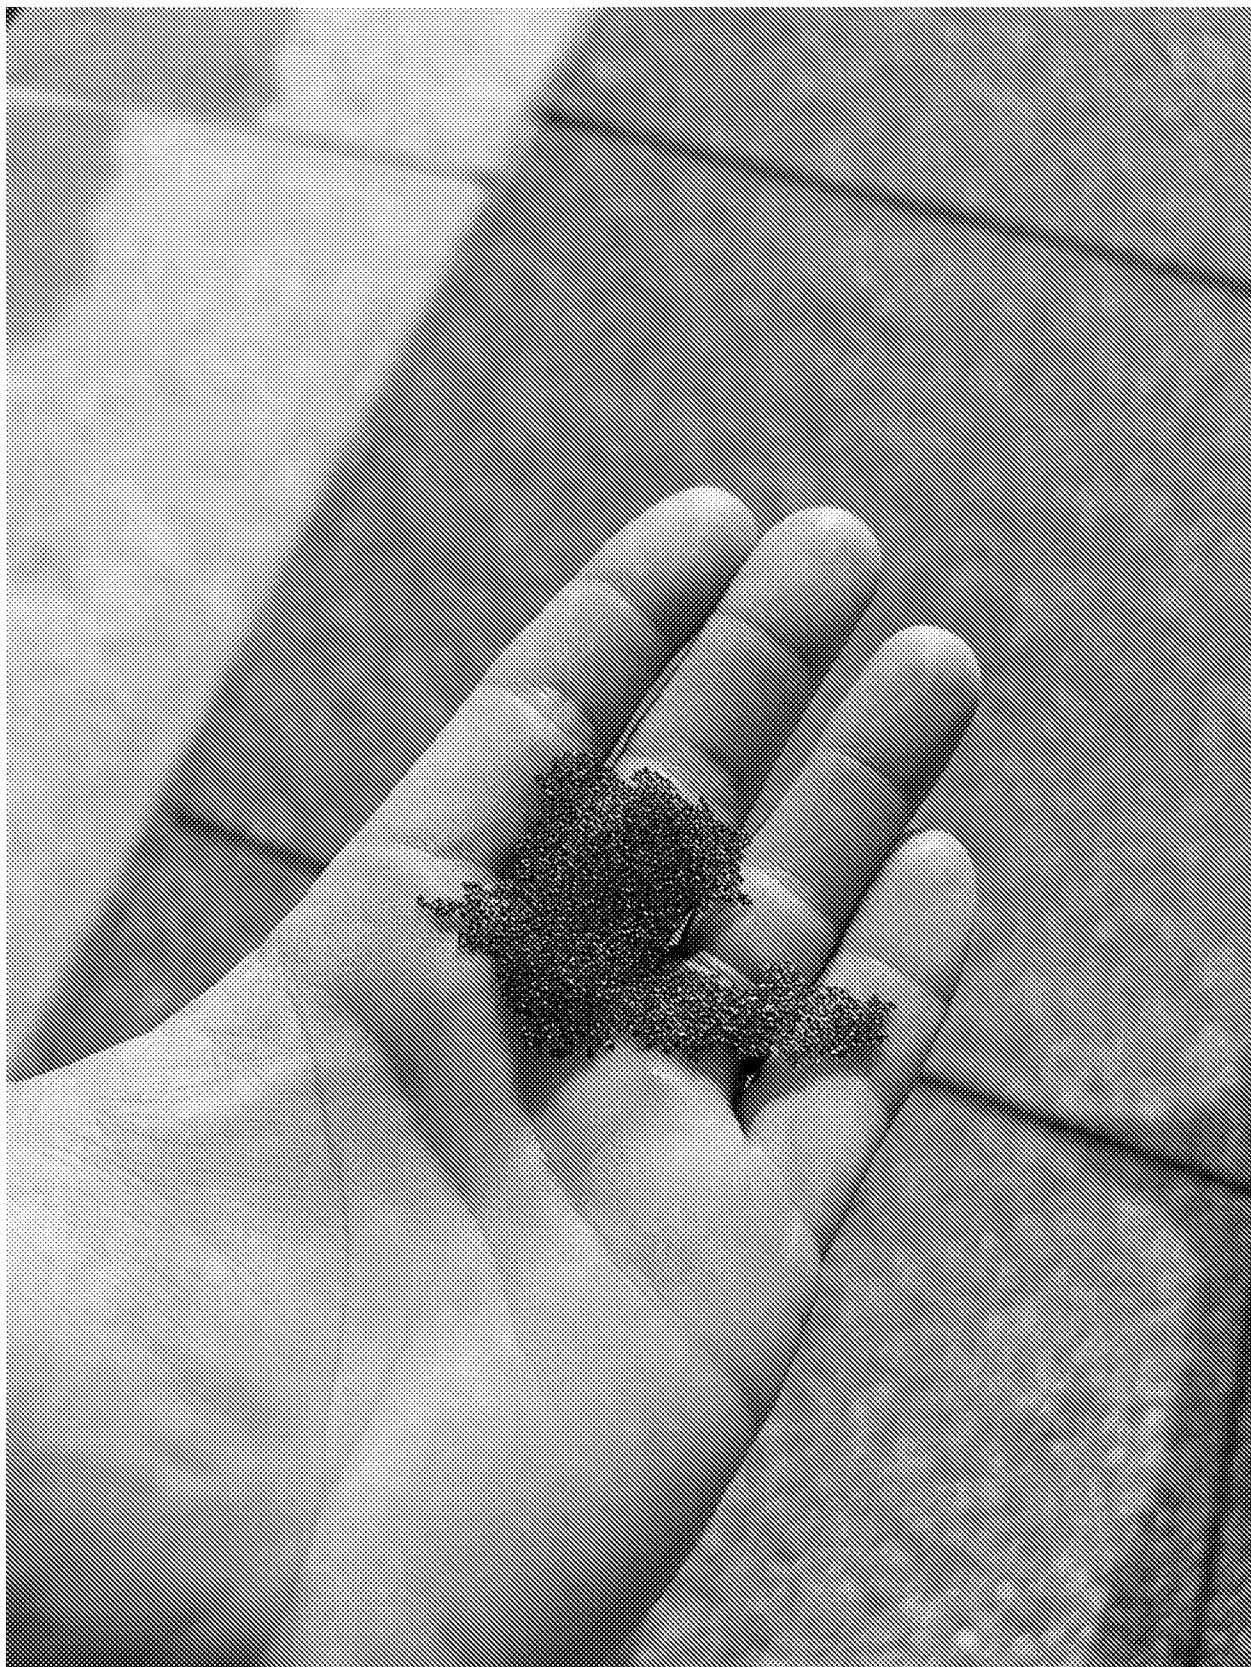
- Only the top layer of liner has peeled. This is very thin and will not impact the strength of the liner.
- The color underneath the peeled area is still dark, “American Flag” blue.
- The total peeled area is small, less than 1 square foot and noncontinuous.
- The contractor stated that the peeled area was “overspray” from spraying the perimeter joint with polyurea.
- I stated my concern that this “overspray” along the perimeter of the pool could lead to a 1’-2’ strip that is vulnerable to peeling. The contractor would not confirm in field if this was or wasn’t a risk.
- The polyurea liner that has peeled does not float in water, so should not be highly visible to visitors and can be vacuumed out along with sediment and algae during the normal cleaning process.
- I walked the perimeter of the pool and did not identify any additional peeling areas.

Notably, the engineer’s email recounted AIC’s explanation that peeling areas around the perimeter were “overspray” and that a one-to-two-foot strip was vulnerable to peeling. This was the area along the perimeter that the defendant is alleged to have pulled up. He also stated that the liner that has peeled does not float in the water and that peeling “will not impact the strength of the liner.” The engineer provided photographs of the peeling area:
